**PURDY (STUMP POND) DAM**

NDI No. PA 00063

**PHASE I INSPECTION REPORT**

**NATIONAL DAM INSPECTION PROGRAM**

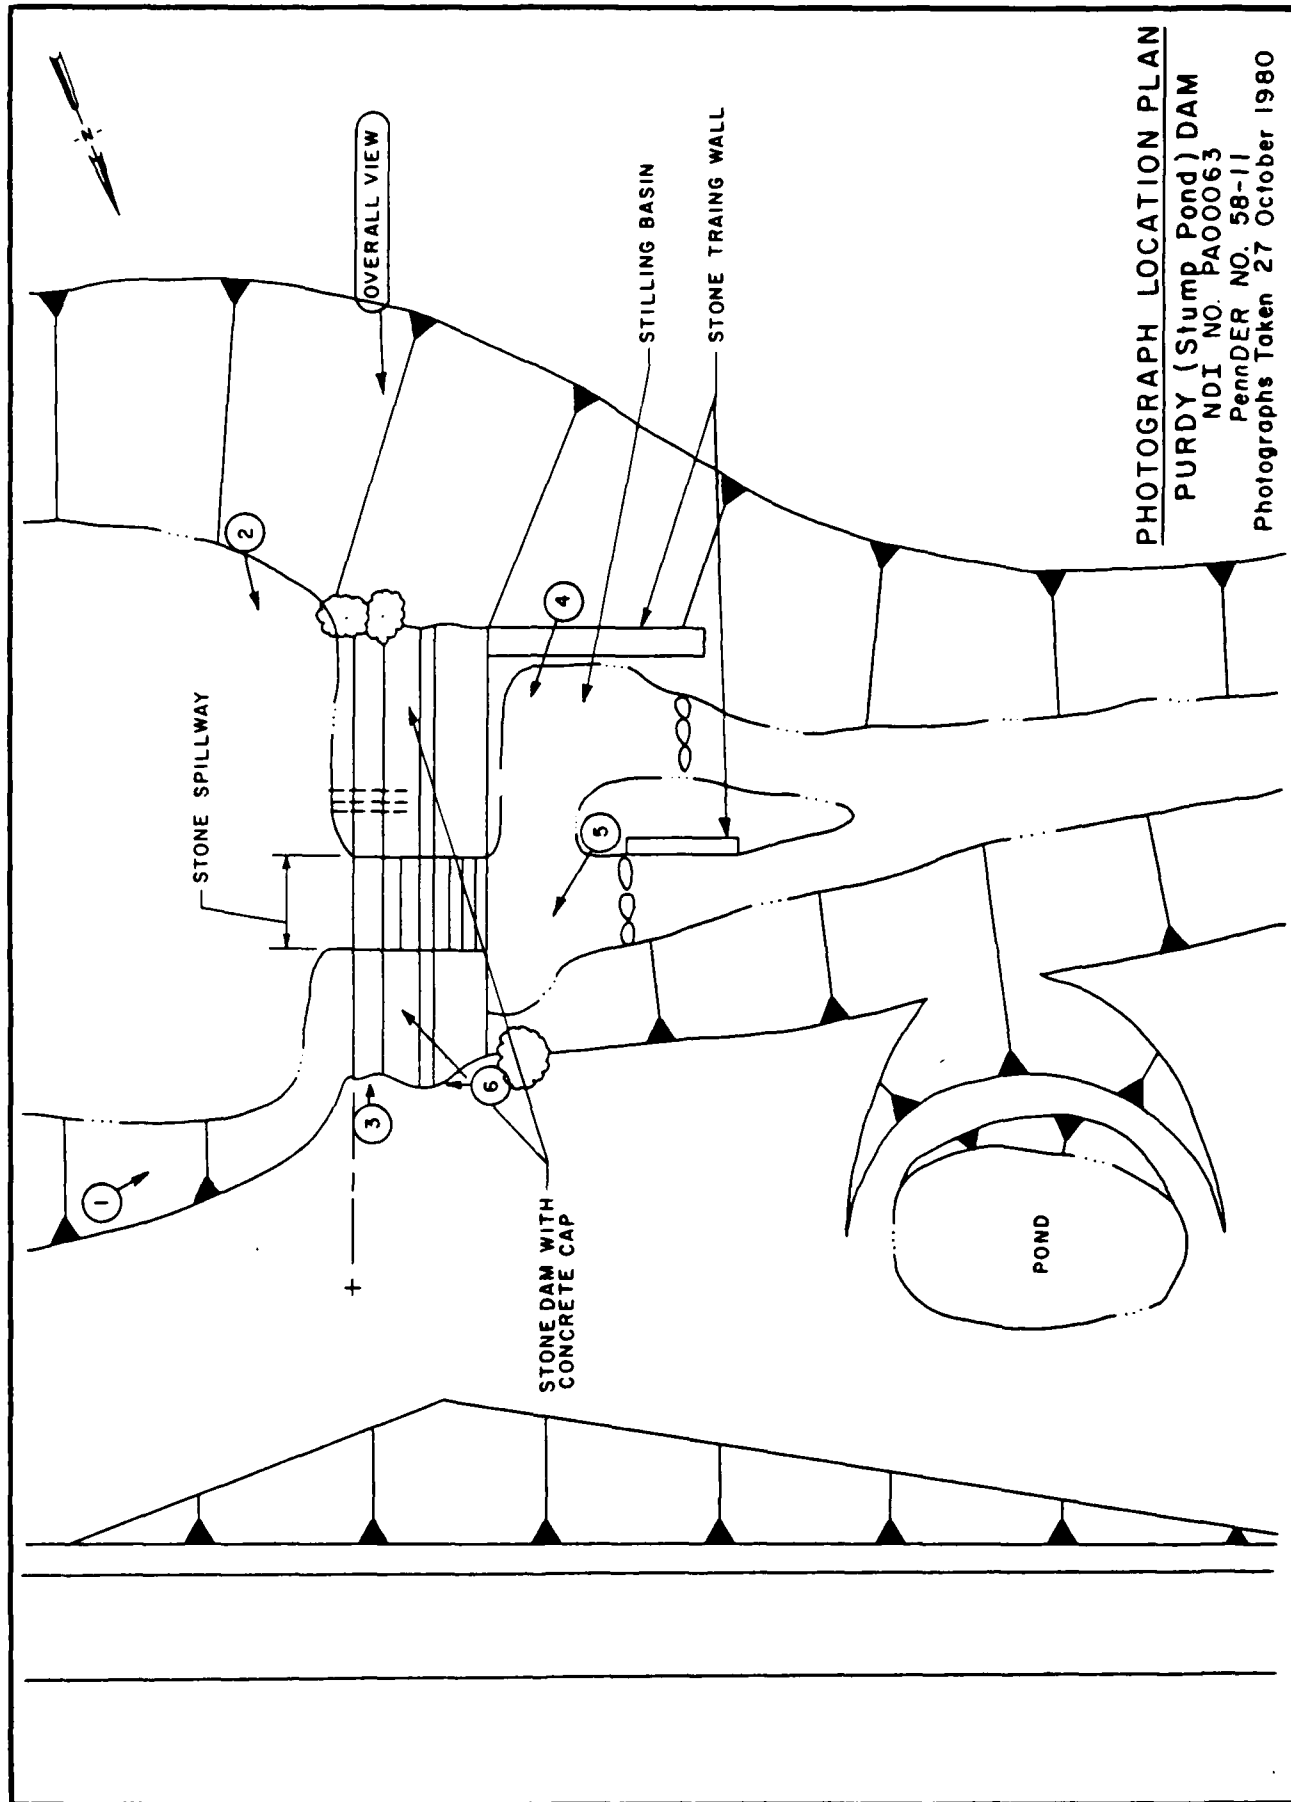
- b. Dam - An erosion gully was observed at the right downstream abutment of the dam. No other significant problems were observed.
- c. Appurtenant Structures - Some debris and sediment has accumulated in the spillway approach channel.

**PHOTO 6. Eroded Area of Right Abutment**
